Manhole Inspection Summary

Manhole # S15CC1006MH

Insp Date: **5/27/09 9:45 AM**

Location Address: **REAR- 3837 PARK HEIGHTS AVE** Cross Street: **KEYWORTH AVE**

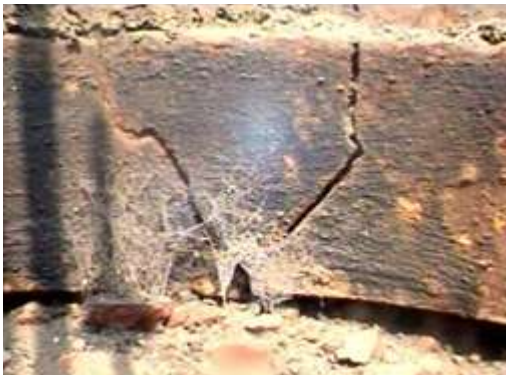
Defect 1

Frame Offset: **6** (in.) Condition: ☐ Sound ☒ **Cracked** ☐ Leaks

CRACKED FRAME AND FRAME
OFFSET

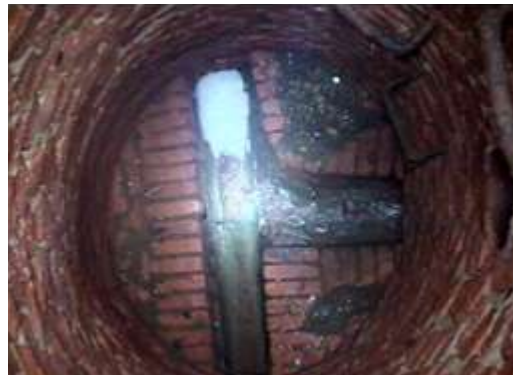
Defect 2

Steps Count: **6** Missing: **0** ☒ **Corroded**

CORRODED STEPS

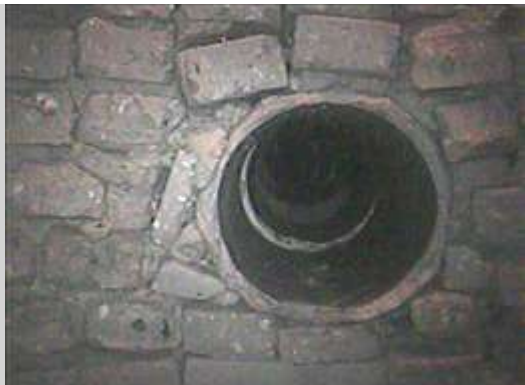
3 O'Clock Inflow

8 in. Circular Gravity Sewer
Pipe In @ 3 O'Clock

Pipe Material: **Clay** ☐ Pipe Lined

Invert Depth: **7.78** (ft.) Flow Characteristics: **Slow**

Infiltration: **None** Pipe Seal Cond: **Cracked**

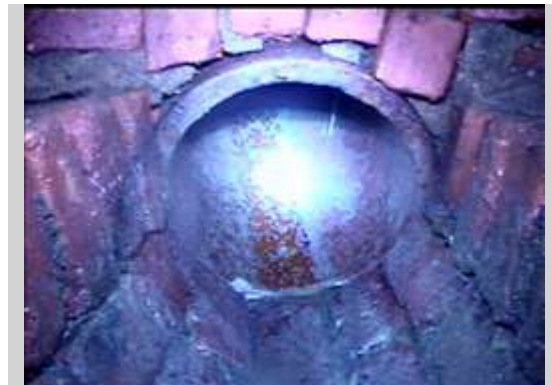
Drop In @ 3 O'Clock

Drop: **Inside** **Direct**

Inv Depth: **11.30** (ft.)

Drop Condition: **Open**

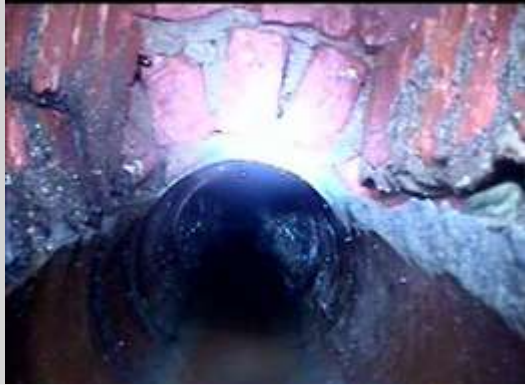
6 O'Clock Inflow

8 in. Circular Gravity Sewer
Pipe In @ 6 O'Clock

Pipe Material: **Clay** ☐ Pipe Lined

Invert Depth: **12.25** (ft.) Flow Characteristics: **Slow**

Infiltration: **None** Pipe Seal Cond: **Sound**
